Memo

Subject: James Island Creek Grab Sampling Results Memo Summer 2021 – data through September 2021

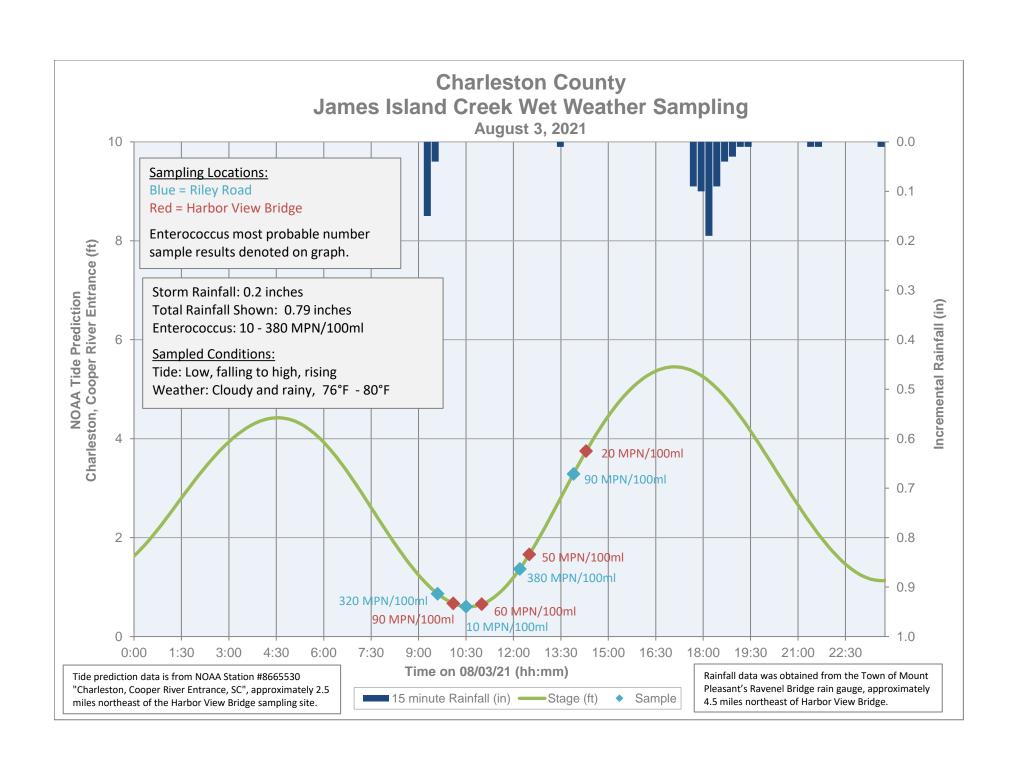
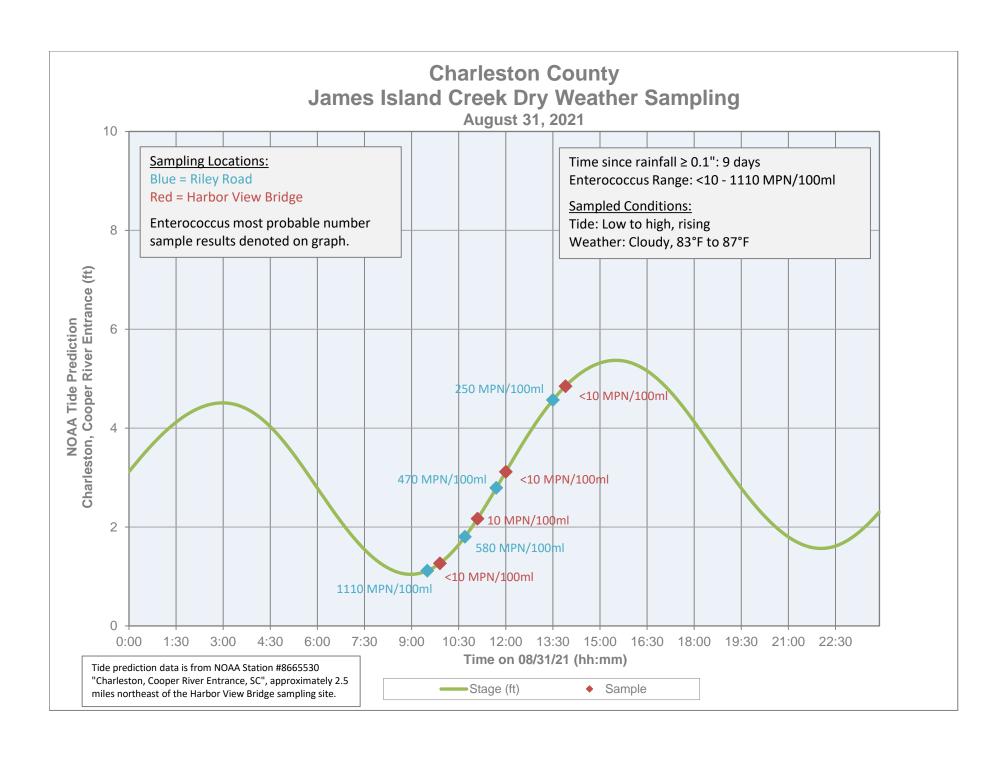
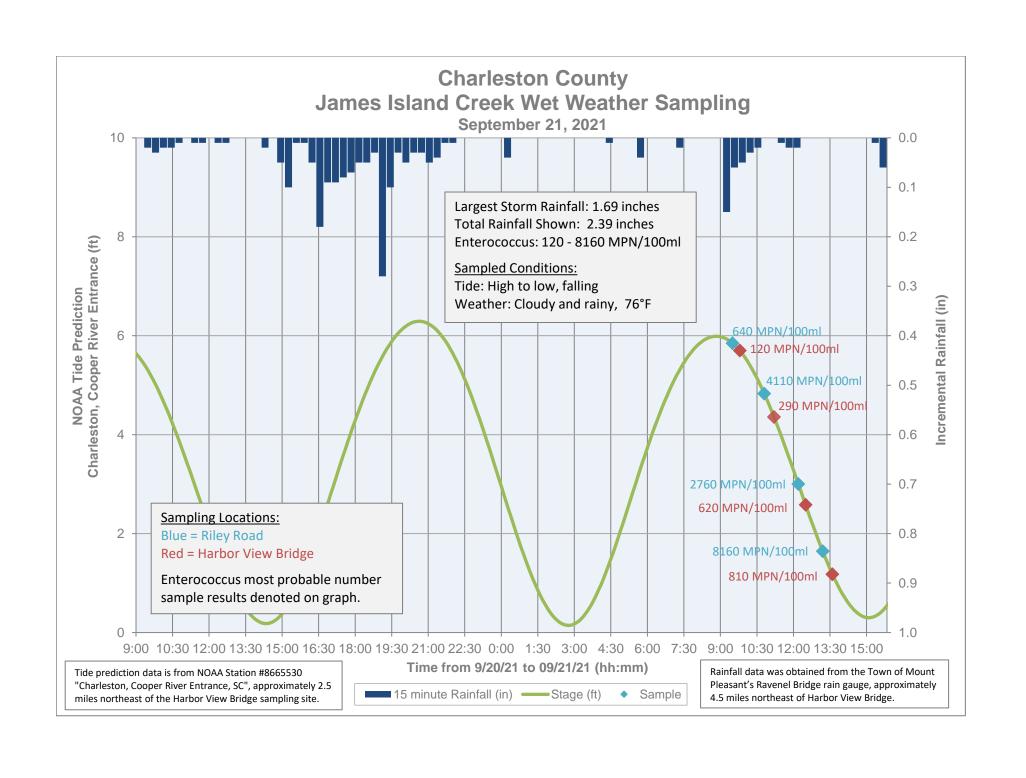
Appendix B: Figures of Individual Storm Grab Sampling Results

to illustrate the grab sampling results at each location along with approximate relative stage in James Island Creek, approximate rainfall data (for wet weather sampling), and observations about weather and tidal conditions. These figures were created for all sampling efforts and are located in Appendix B in chronological order. Available tide prediction and rainfall data were used to best approximate conditions in James Island Creek during sampling. Tide prediction data was obtained from NOAA station #8665530 "Charleston, Cooper River Entrance, SC" which is approximately 2.5 miles northeast from the Harbor View Bridge sampling location. For the wet weather sampling efforts, rainfall data was obtained from the Town of Mount Pleasant's Ravenel Bridge rain gauge, approximately 4.5 miles northeast of Harbor View Bridge. This gauge represents the closest source of incremental rainfall data that is available to approximate rainfall in the James Island Creek watershed. For the purposes of analysis and discussion, a "storm rainfall" was established which was a running sum of rainfall until 3 consecutive hours go by with zero additional precipitation that occurred closest to the time of sampling. In some cases, if there was additional rainfall outside the "storm rainfall" that was relevant to describing the watershed conditions, analysis may refer to a "total rainfall" or "largest storm rainfall" that is larger than the "storm rainfall" that occurred closest to the time of sampling.

- The August 2021 event (8/3/2021) had a rainfall total of 0.20" prior to sampling with samples collected from low
 to high tide, as the tide rose. The bacteria levels were relatively low, in the "tens" at Harbor View Bridge and
 varied between "tens" and "hundreds" at Riley Road. Additional rainfall was forecast to occur before and during
 the sampling window but did not actually occur until later in the day after the available sampling window (limited
 by laboratory hours).
- The September 2021 event (9/21/2021) had a rainfall total of 2.39" prior to and during sampling with samples
 collected from high to low tide, as the tide fell. This larger storm event correlated with relatively high bacteria
 levels (results in the "hundreds" at Harbor View Bridge and results in the "thousands" at Riley Road).

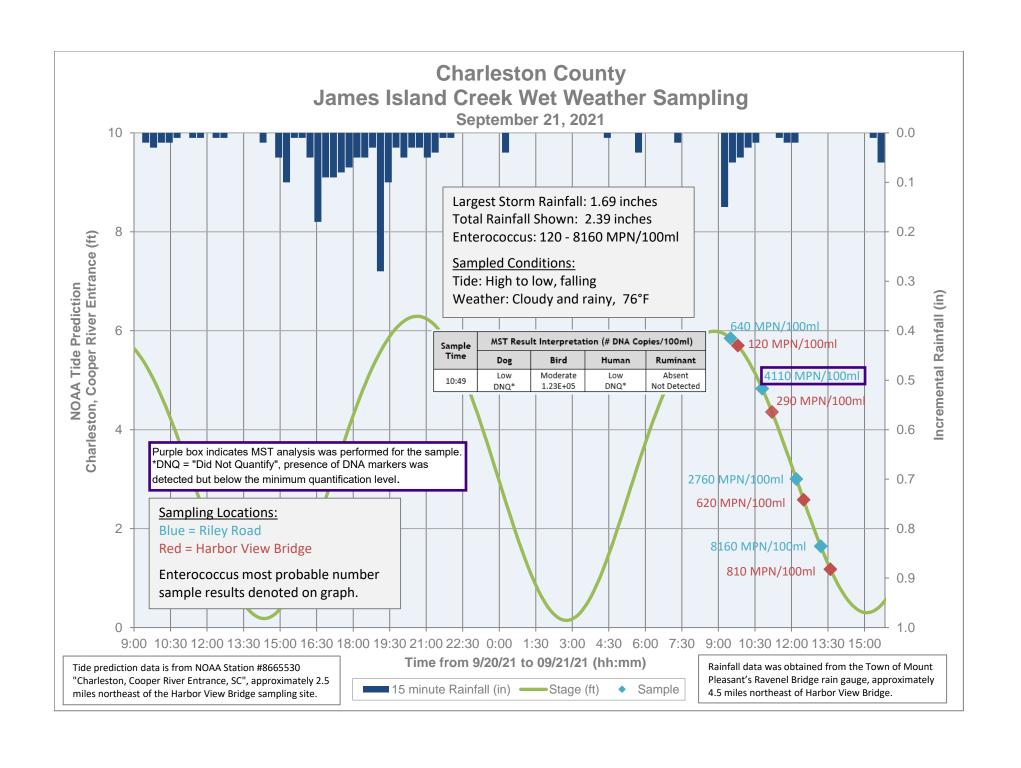
Appendix C: Microbial Source Tracking Results Graphs

Total Rainfall is included in **Table 2** as a general indicator of size of the rainfall event. Other parameters such as rainfall distribution and intensity, tidal characteristics, and time of sampling relative to rainfall are also important to understand the sampling conditions as additional MST analyses are included. Appendix C contains grab sampling figures showing these parameters for each event that included MST analysis, along with visual indication of which samples were analyzed.

The sample chosen from the September 2021 sampling effort was from the middle of the sampling period at Riley Road. It was collected during a high falling tide, the second falling tide that occurred during this extended period of rainfall. The Enterococcus concentration was relatively high, being of the "thousands" order of magnitude. As indicated in **Table 2**, the MST analysis indicated a stronger presence of Bird than the other sources. Dog and Human were present in the sample, but below the minimum quantification limit (DNQ). Ruminant (e.g., deer, goats, sheep) was not present in the sample. More MST data will be collected to add to observations about bacteria sources for other storms during different combinations of conditions and at other times of year.
